LOCHMERE DAM

NH 00015

PHASE I INSPECTION REPORT  
NATIONAL DAM INSPECTION PROGRAM

12. REPORT DATE November 1978		13. NUMBER OF PAGES 45
14. MONITORING AGENCY NAME & ADDRESS (if different from Controlling Office)		15. SECURITY CLASS. (of this report)  UNCLASSIFIED
		15a. DECLASSIFICATION/DOWNGRADING SCHEDULE

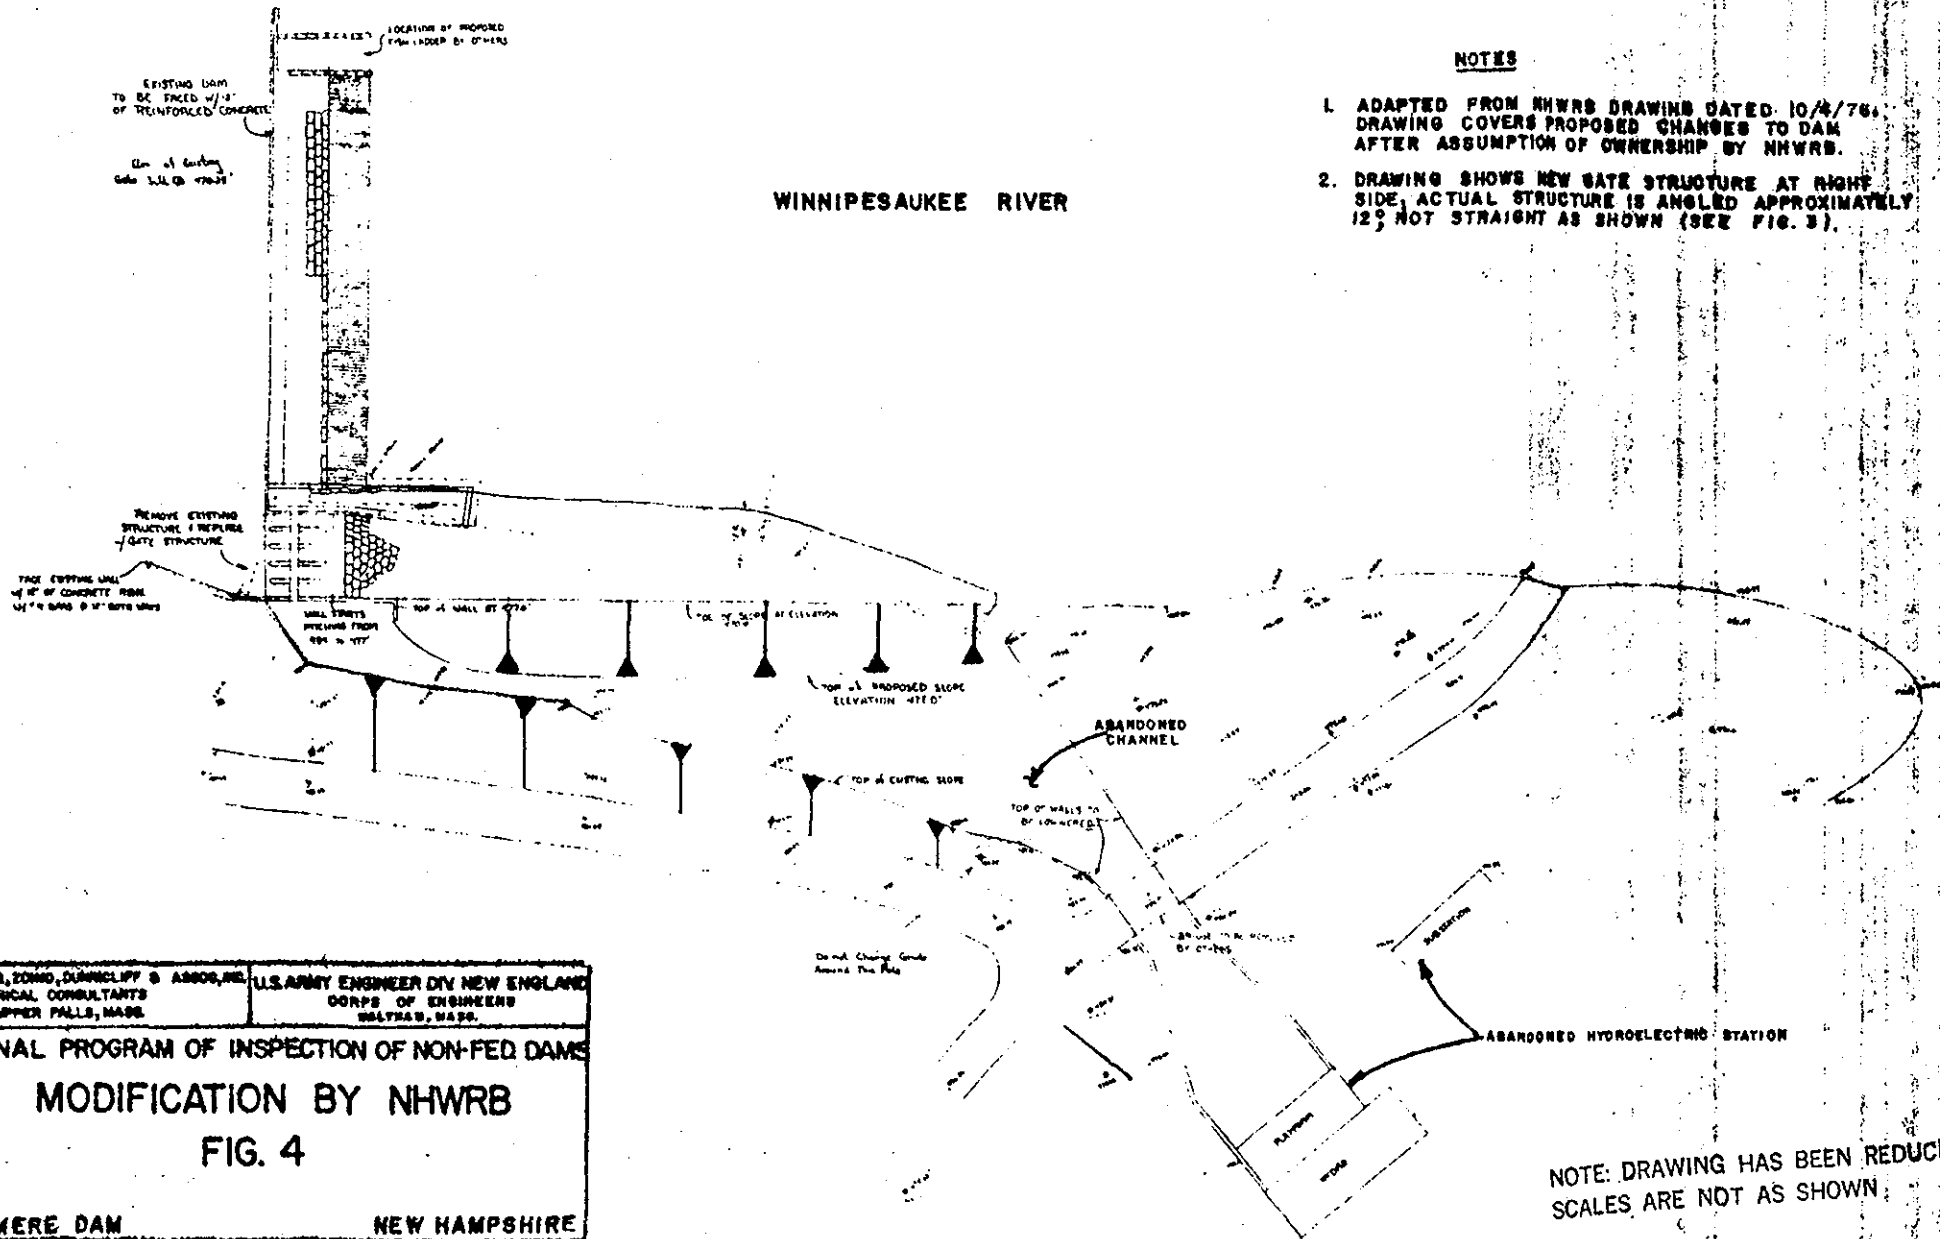
The right side of the dam formerly discharged into a channel which carried the water to a hydroelectric plant approximately 400 feet downstream. The plant, however, is no longer in service and the channel is now backfilled. (Fig. 4)

In 1957, PSCNH made some alterations to the 161 foot long section of the dam between the intermediate pier and the left abutment. Significant alterations took place in 1976 when the NHWRB constructed the 5 bay sluice gate structure on the right side of the dam and backfilled the channel to the hydroelectric plant which had been idle for at least 10 years (Fig. 4).
